Hearing Implants and MRI: Issues and Safety

Darla Franz, VP Education
MED-EL North America

Martin Zimmerling, Head of Implant R&D
MED-EL Headquarters

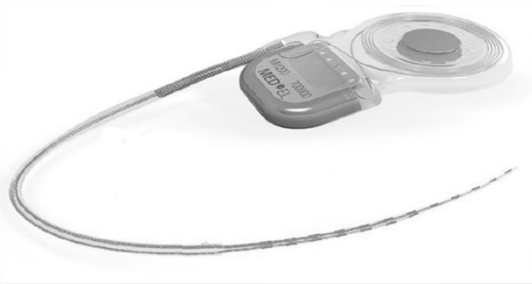
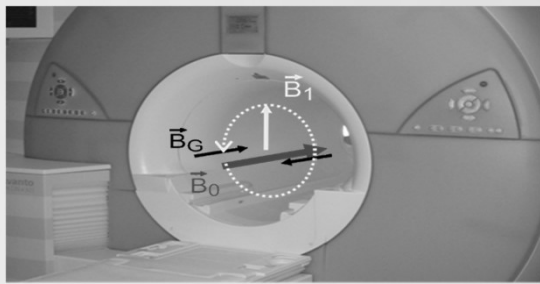
Possible Interactions with Implants

- **Static Magnetic Field:**
 - Linear force and torque
 - Magnet dislocation
 - Demagnetization
- **Radio Frequency Field:**
 - Voltage induction
 - Unintended stimulations
 - Heating (electrode contacts)
- **Magnetic Gradient Fields:**
 - Vibrations of the implant
 - Implant damage
 - Unintended stimulations
 - Heating (housing)
- **Influence on the MRI System:**
 - Image artifacts

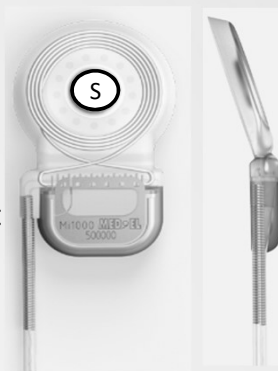
Magnet Design for SONATA and CONCERT

Torque = in standard position the magnet is nearly perpendicular to B_0 . Torque is exerted, trying to align the magnet

Demagnetization = If the magnet cannot align, there is a risk of the magnet weakening

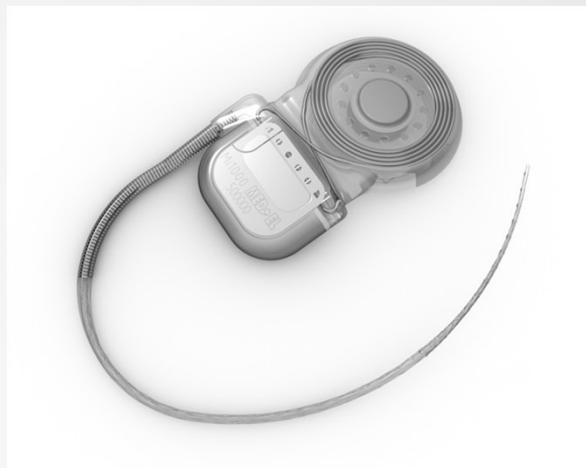
Design Feature to Reduce Pressure Footprint

Magnet fixation disc distributes lever arm force when torque is exerted

- Large pressure footprint with **very little pressure**
- Feature of all MED-EL titanium housing Implants

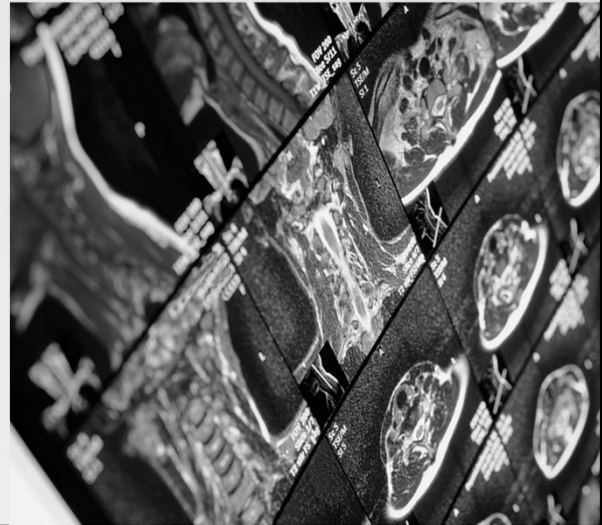
Tests to Demonstrate MRI Safety

- All testing done to ASTM standards
- Some testing done by MED-EL using a clinical scanner
- Some testing done at external test houses

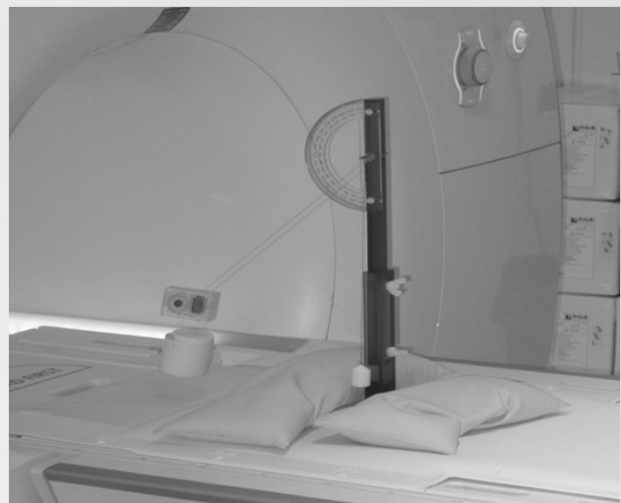
- Force at entrance of scanner vs gravitational force
- If the angle of the attractive force is less than 45 degrees, the implant isn't subjected to a force greater than gravity at the scanner entrance

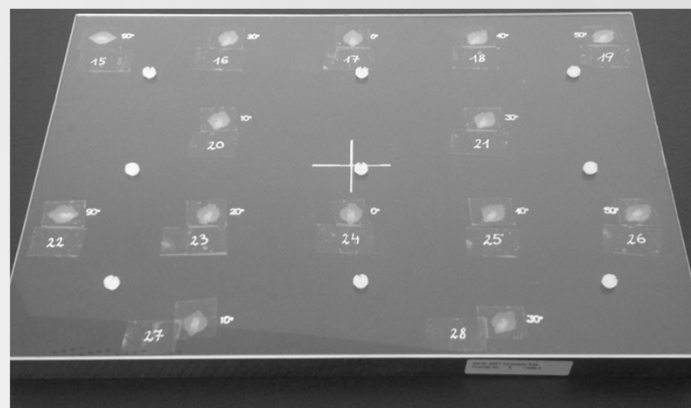
- Magnet weakening occurs within a fraction of a second
- Test before and after
- Repeat x 10
 - Demagnetization isn't linear
 - If orientation angle is unchanged, subsequent scans don't increase the exposure

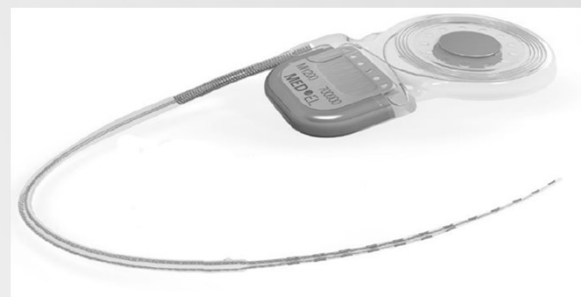
Testing done at external test houses:

- Heating (gradient fields)
- Heating (RF field)
- Unintended stimulation (gradient fields)
- Unintended stimulation (RF field)
- Robustness against MRI sequences
- Image artifacts

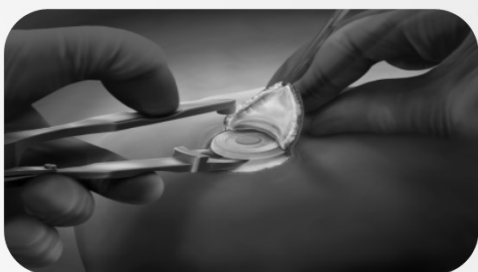
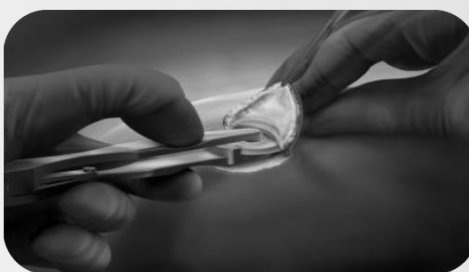
Magnet Removal Tool

The magnet is pushed out to the bottom

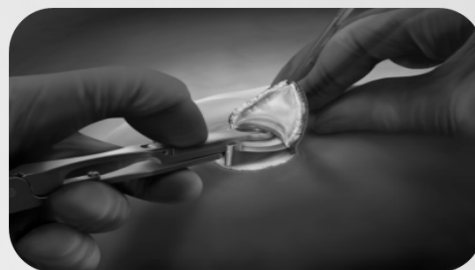
Magnet Insertion Tool

To reinsert the magnet into the implant

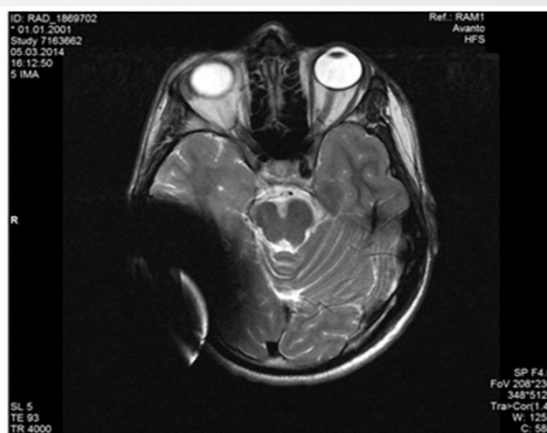
MR Image Artifact at 1.5 Tesla

With implant magnet

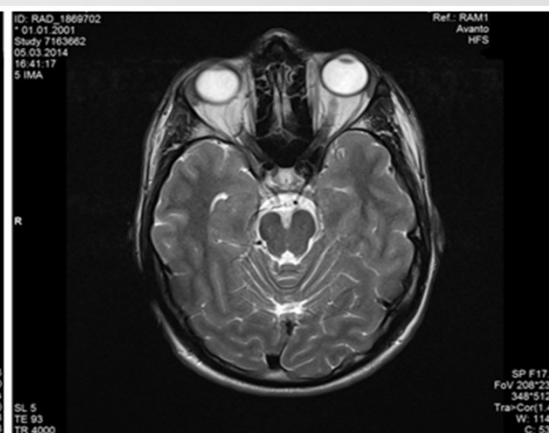
With non-magnetic spacer

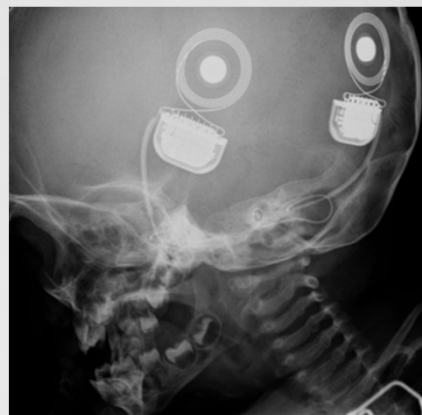
The SYNCHRONY Implant

- **Patented** magnet design
- **FDA approved** and labelled as
MR conditional at 1.5 and 3.0 Tesla
(with magnet in place)
- Magnet is optionally removable
- Safe and comfortable for the patient
- Increased image resolution for the physician

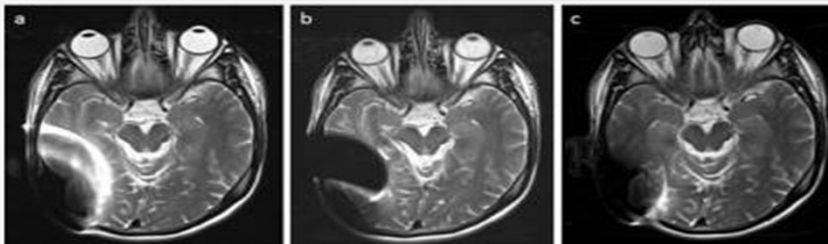
orientation: normal

neck stretched

neck bent

T2w TSE sequence

MRI artifact can be shifted out of slice by head orientation.
